1. PROJECT NAME Rehabilitation of Moores Corner Schoolhouse/Museum

**MOORE'S CORNER SCHOOLHOUSE  
NORTH LEVERETT, MASSACHUSETTS  
LEVERETT HISTORICAL SOCIETY**

**EXTERIOR CONDITIONS ASSESSMENT**

SEPTEMBER 2024

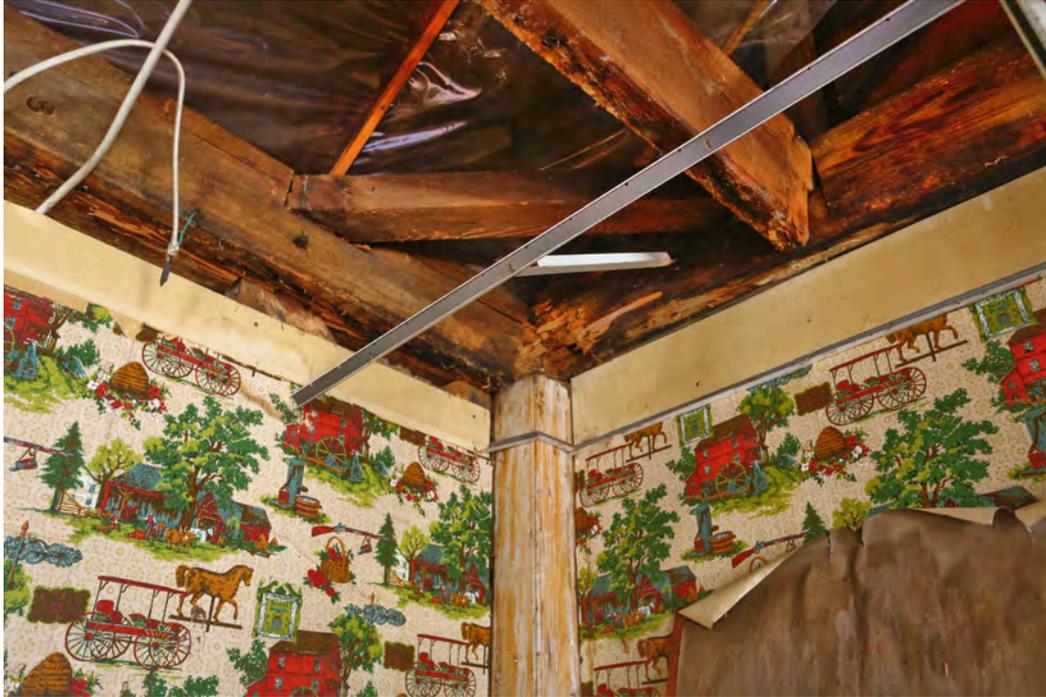
Fig. 5. Second floor, northeast corner. Detail of rot at the top of the corner post and ends of wall plates.

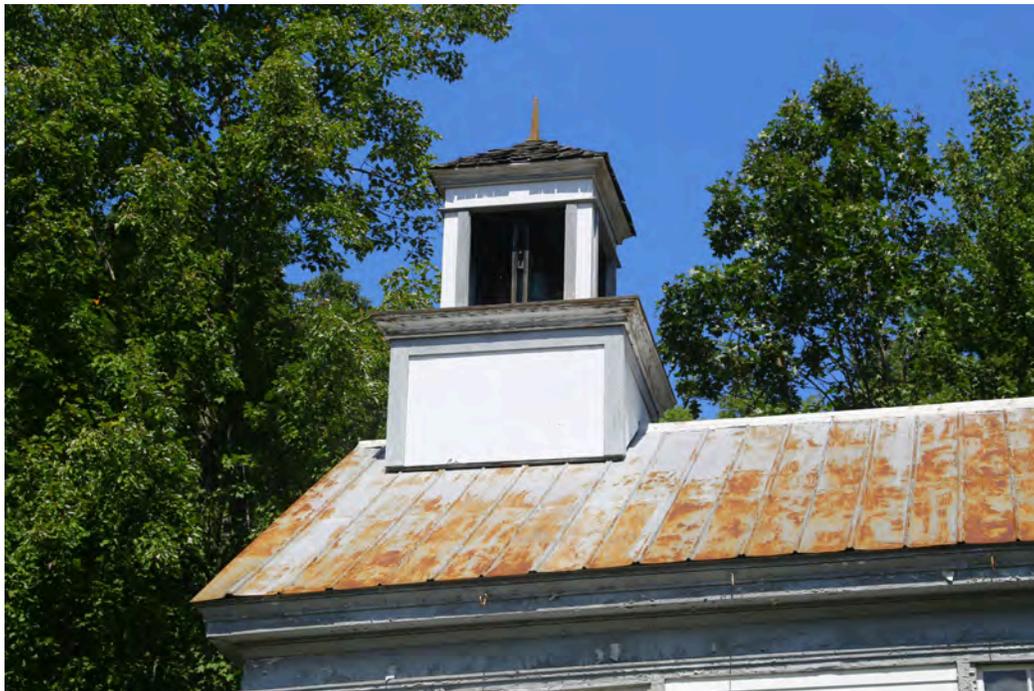
Fig. 6. Detail of the bell tower and surrounding metal roofing. Rusted surface of the roofing is typical across the entire roof.

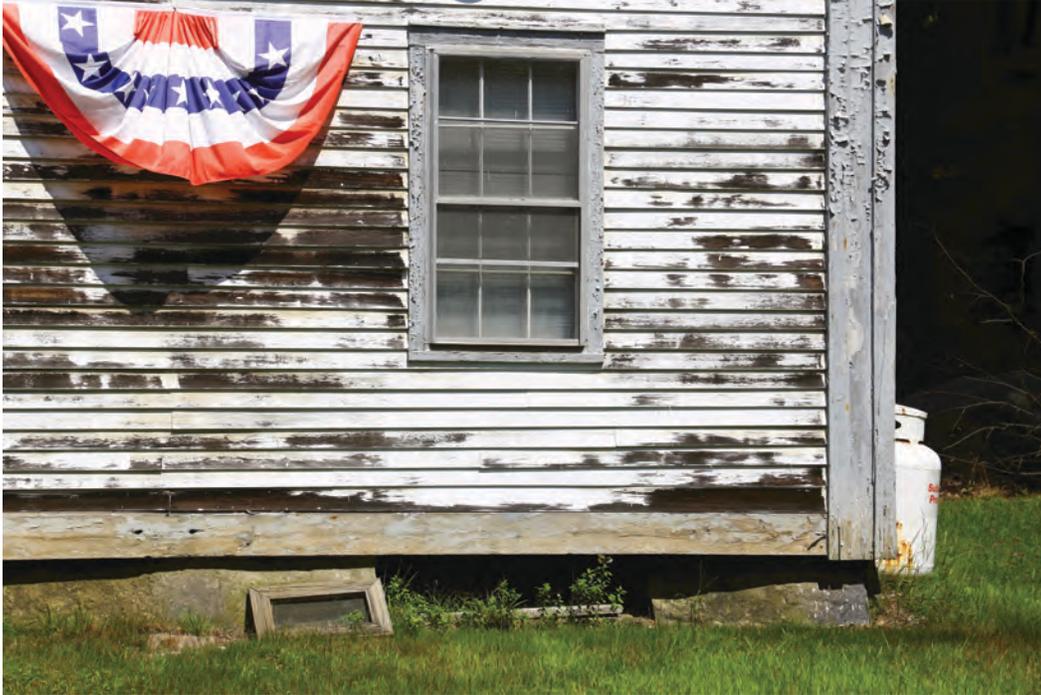
*Fig. 7. South elevation, east corner. Representative appearance and condition of clapboard siding and wood trim elements.*

- Replace/repair deteriorated/damaged wood siding and trim with new material to match the existing.

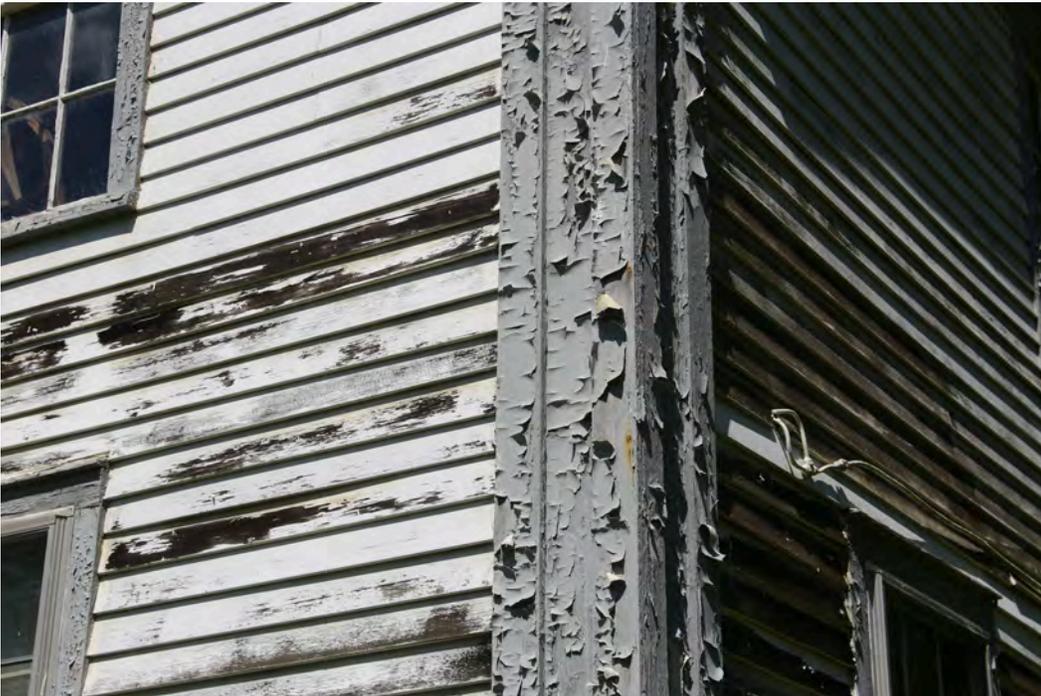
*Fig. 8. Detail of southeast corner showing failing paint finishes on clapboards, corner boards and window frames.*

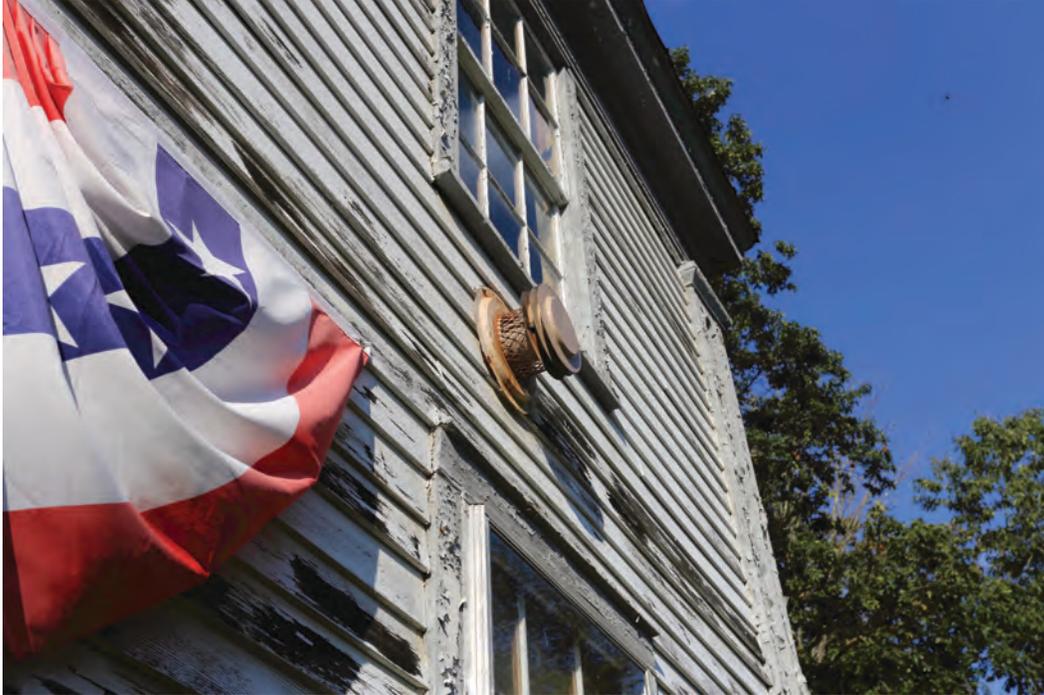
Fig. 9. Example of direct vent run through side wall.

- Remove direct vent pipes and gas lines. Patch in new sheathing and siding to cover holes left by vents. Stagger joints in siding repairs.
- Repair/patch/refasten locations of punky/rotted trim, holes where vermin have gnawed through woodwork, and/or failing or poorly executed Dutchman repairs.

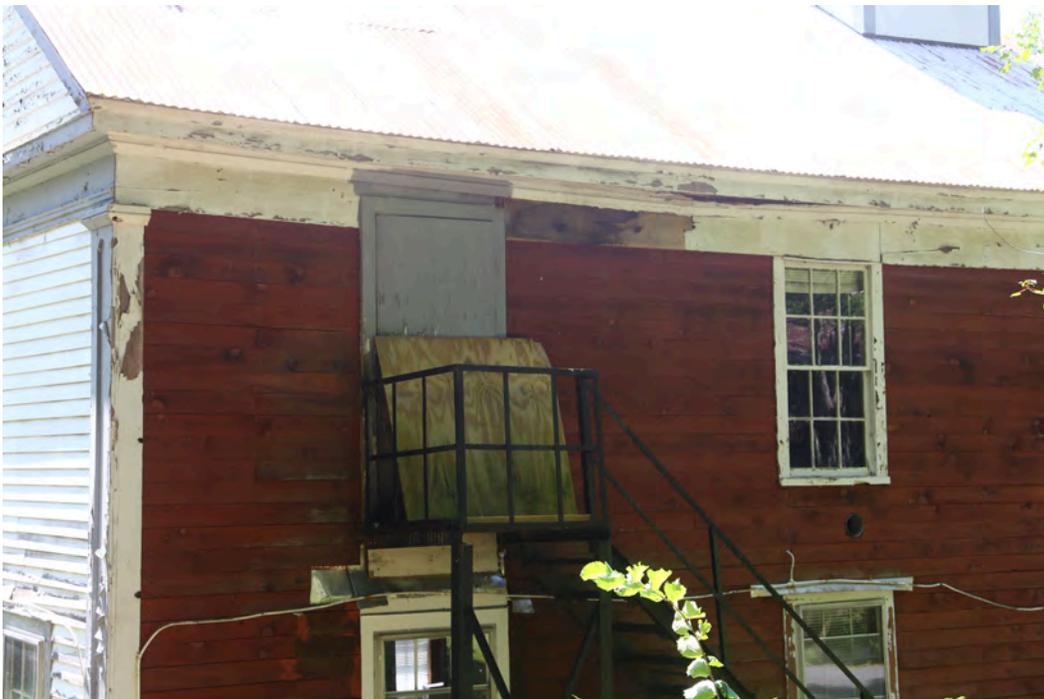
Fig. 10. North elevation showing area of rotted soffit. The corner and portions of the surrounding trim and siding here should be opened up to expose the full extend of conditions shown in Figure 5.

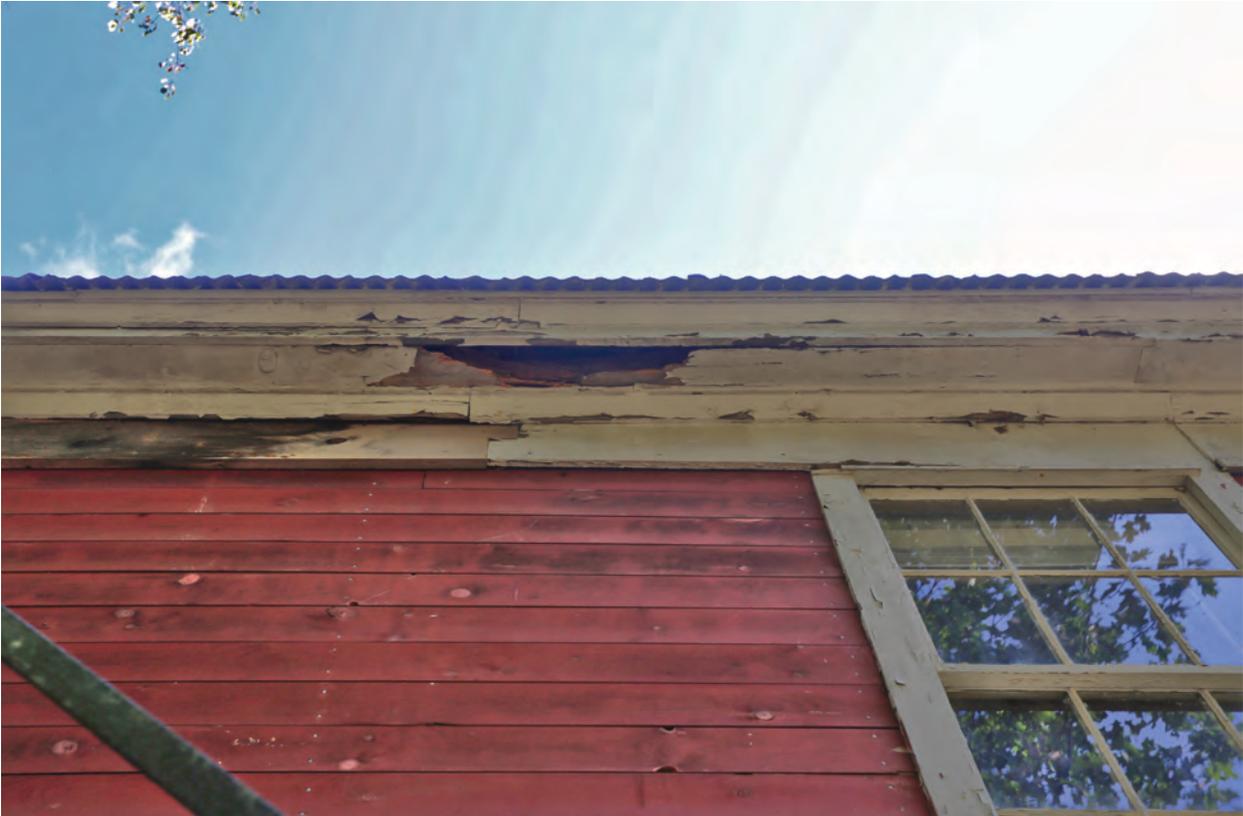
Fig. 11. North elevation, detail of the soffit shown in Figure 10.

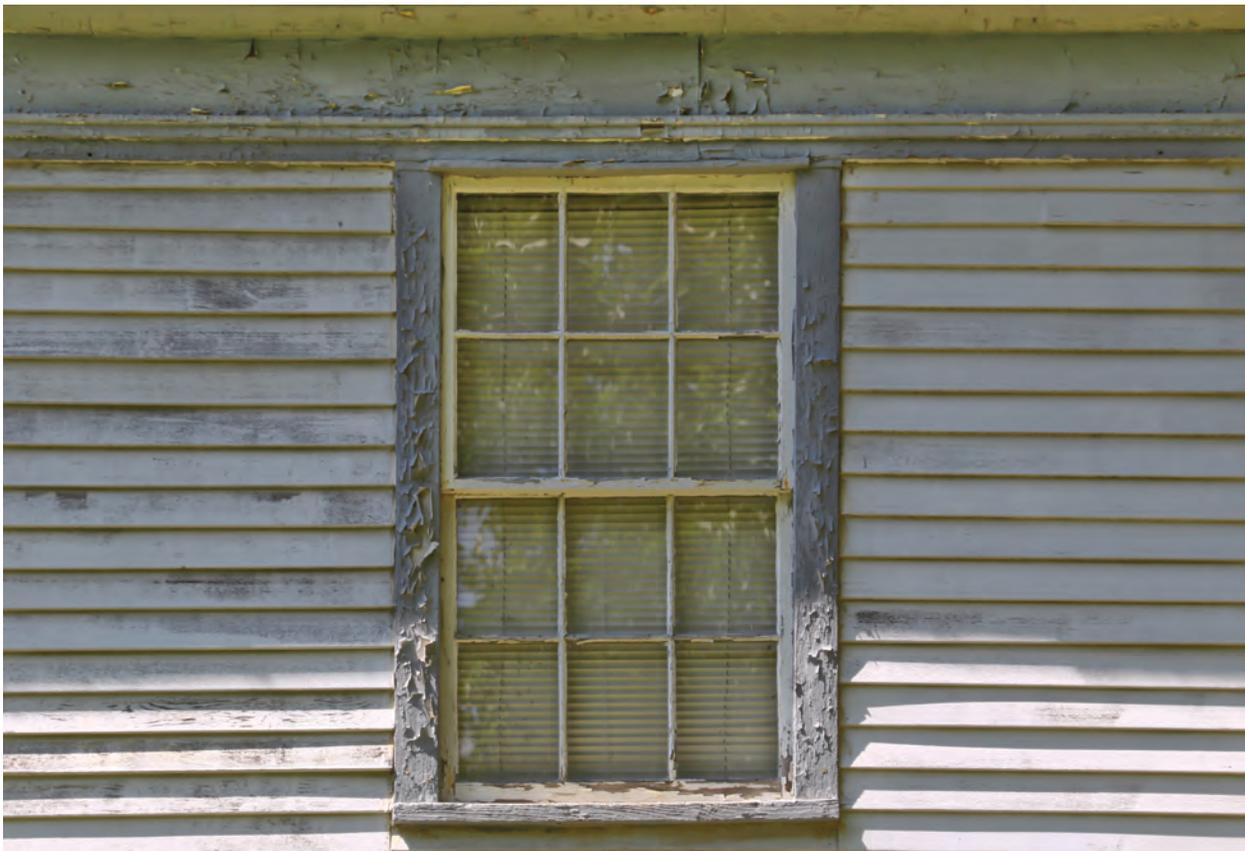
All of the wood windows suffer from deferred maintenance, and as a consequence exhibit the typical issues normally seen as a result (Fig. 12). These include, failing paint finishes, weathered wood and various degrees of failing glazing putty. No serious rot was observed; however, some deteriorated/rotted wood will likely be revealed as the woodwork is probed and prepped for painting.

*Fig. 12. Representative example of the typical exterior conditions of the wood frame windows. Note the failing paint finishes and missing glazing putty on the sash.*

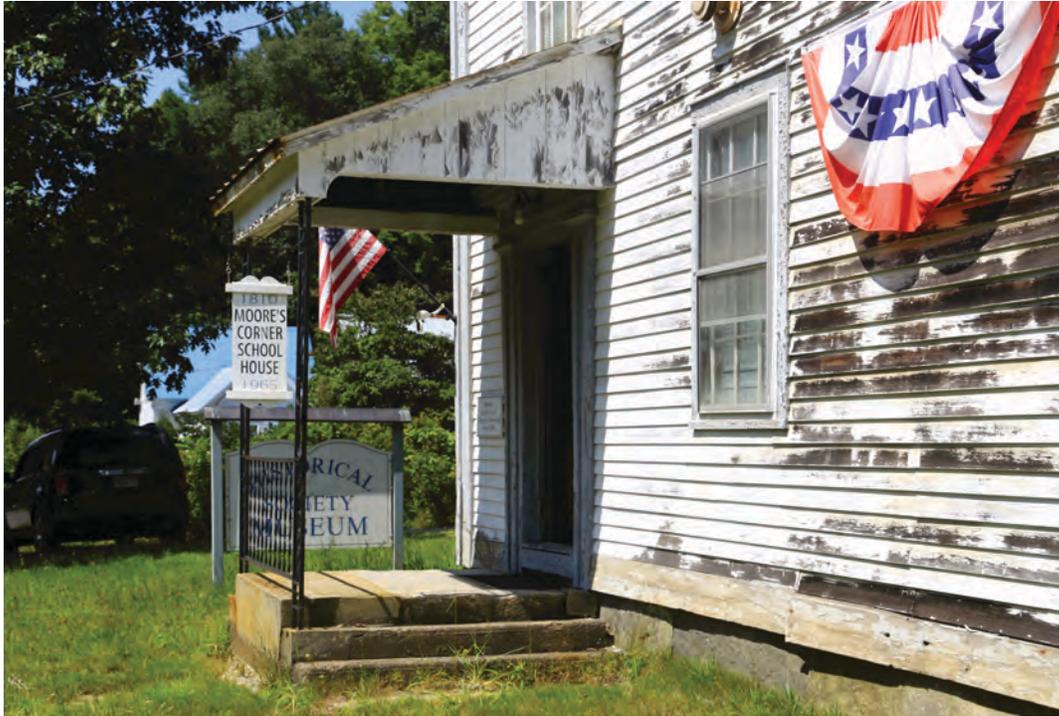
Fig. 13. Detail of the south entry, portico and steps.

- Prep and paint wood door, trim, portico and metal rail.
- Clean concrete steps. Power wash at a low setting, but strong enough to remove stains and soiling.

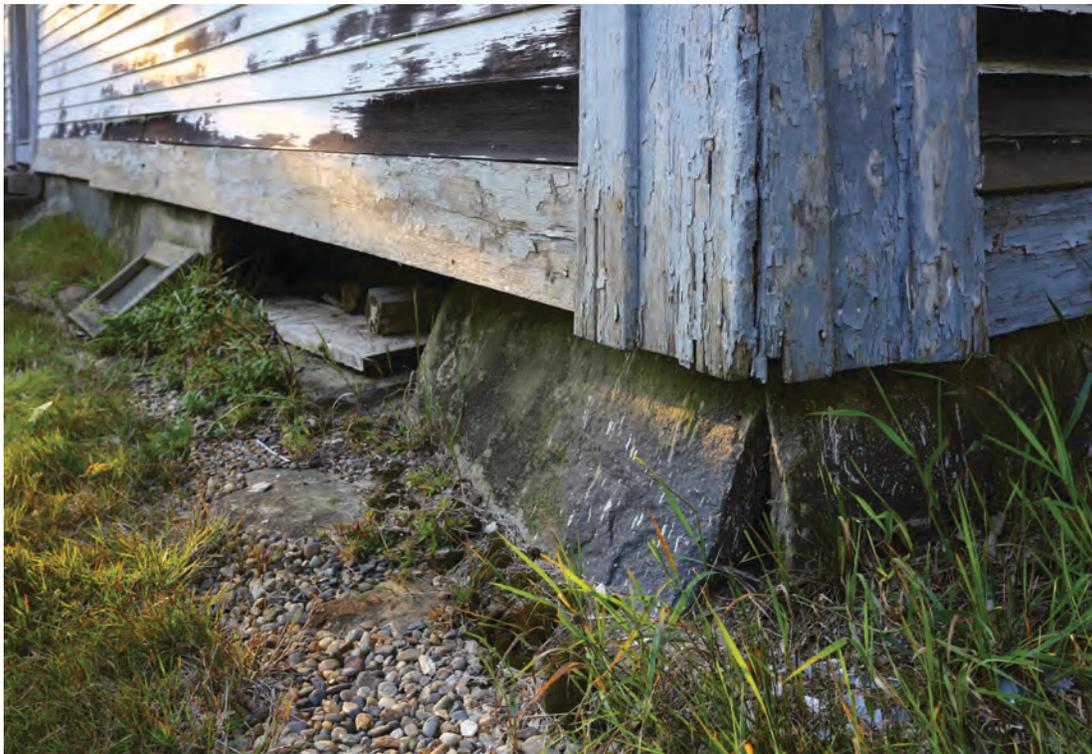
Fig. 14. Detail of the foundation at the southeast corner of the building. Note missing stone and tilted angle of the corner stones.

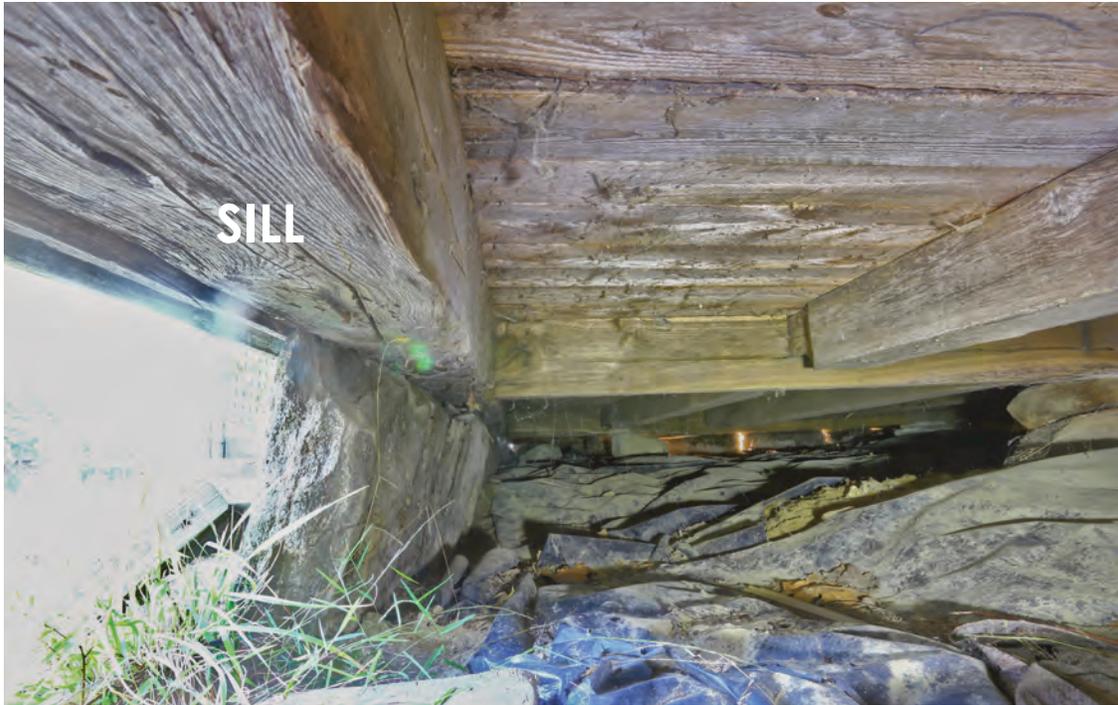
Fig. 15. South elevation at east end of the building where stone in Figure 14 is missing. View looking west. Note how sill bears on foundation stone.

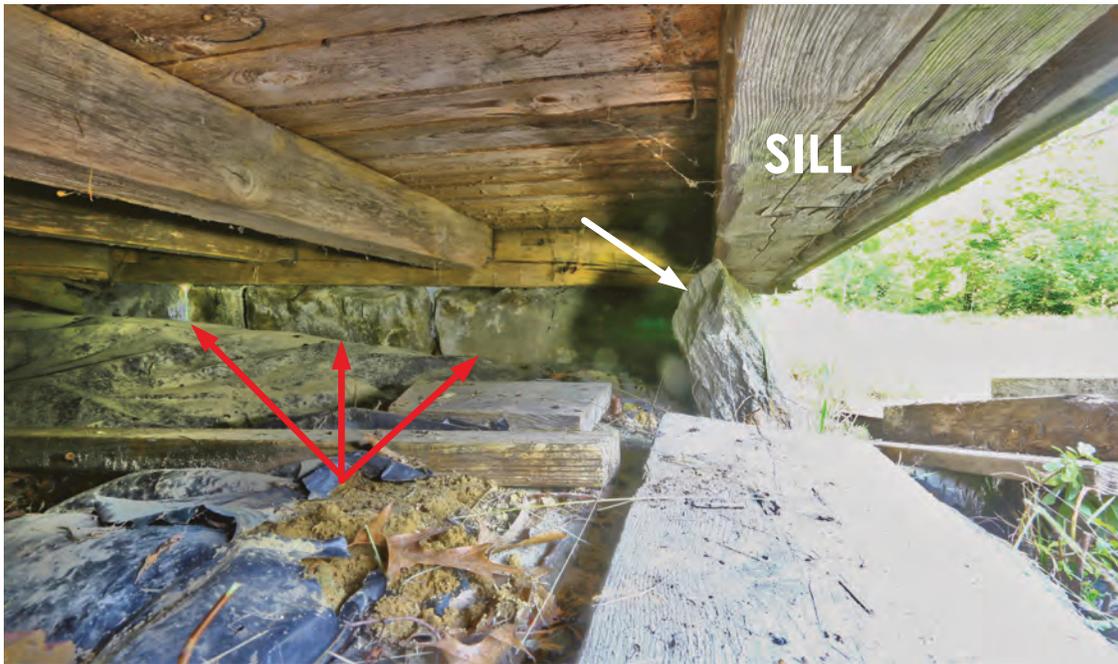
Fig. 16. South elevation at east end of the building where stone in Figure 14 is missing. View looking east. Tilted stone (white arrow) is the same seen in Figure 14. Red arrows point to foundation stones on the east side of the building.

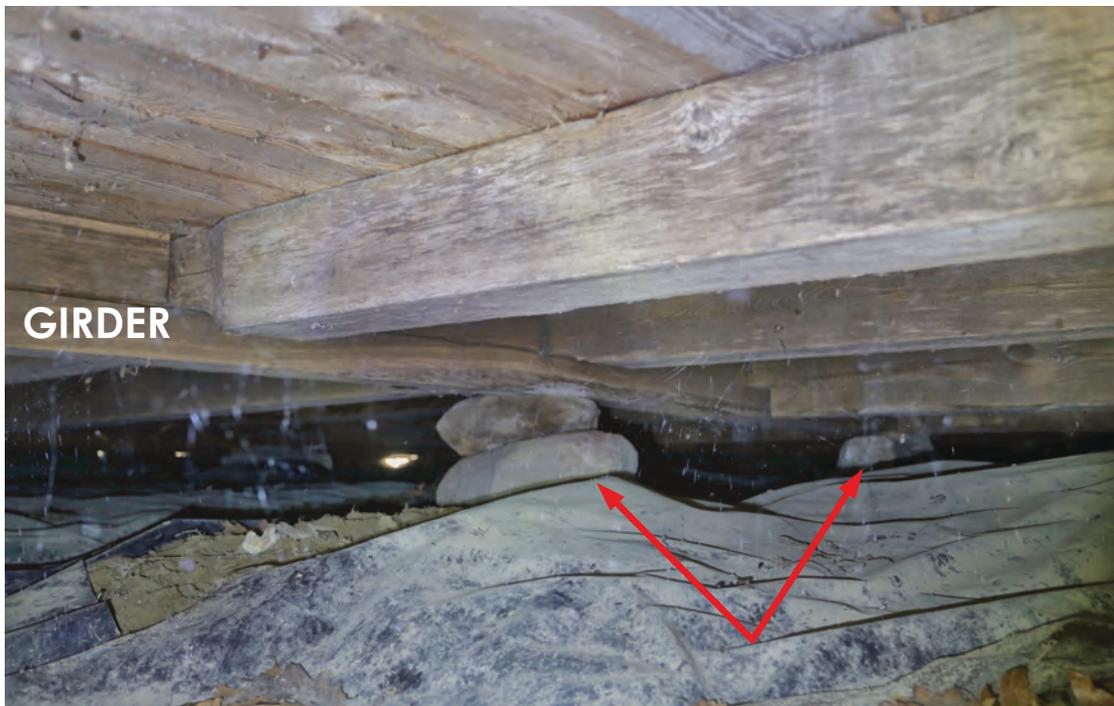
Fig. 17. Detail of the girder supported by piles of stone.

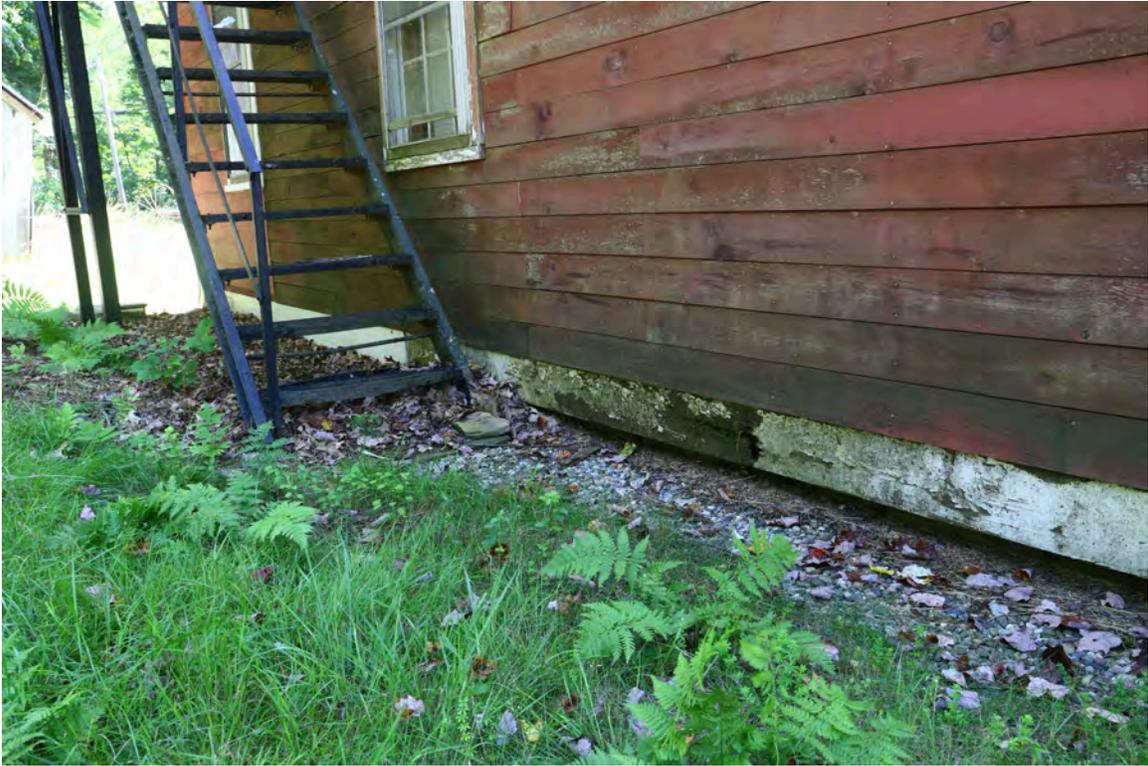
*Fig. 18. North elevation. Note how high the grade is in relation to the water table. The grade should be slightly lowered and pitched away from the building. This section of water table (approximately 16') should be replaced.*

- Lower grade on the north side of the building approximately 6” - 8” making sure to maintain positive drainage. Do not undermine foundation stones. Lay an 18” +/- perimeter of crushed stone over filter fabric around at least the north, west, and east sides of the building (and south if gutters are not installed.)
