DEP Notification Item 2b. Figure 1. Fire Hydrant Water Source. Plan of the Public Access area showing the location of proposed removal of cattails blocking small brook/rivulet and against lawn/picnic area blocking view. Cattails are growing their way toward the boat ramp. Approximate area of removal along bank is 24x8ft. There is also a small area (approximately 10x8ft) in the middle of the brook where cattails are beginning to grow that could be removed by hand with volunteer help. It will soon fill the channel. The hydro-rake will not reach that far. See DEP Notification Item 2b Figures 2 and 3 (next page).

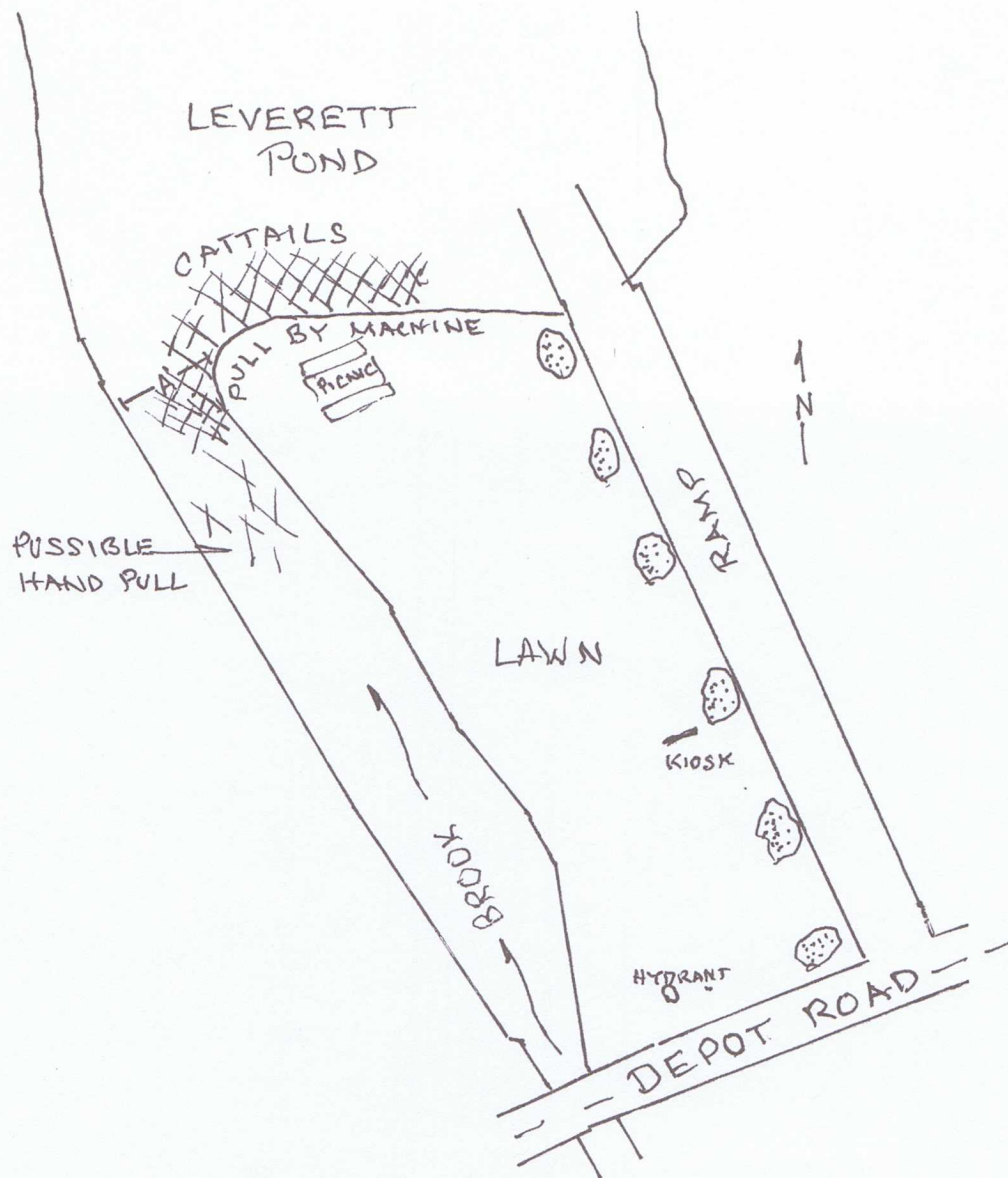
N.B. It is important to keep water flowing in this stream so that the now dry fire hydrant can be again made operational again. The intake has been filled with silt. See support from Fire Chief Ingram in Attachment 2 of the General Project Description B2.
